APPLICATION NOTE:

RUNAWAY LI-ION BATTERY EXPLOSION DURING CHARGING / DISCHARGING

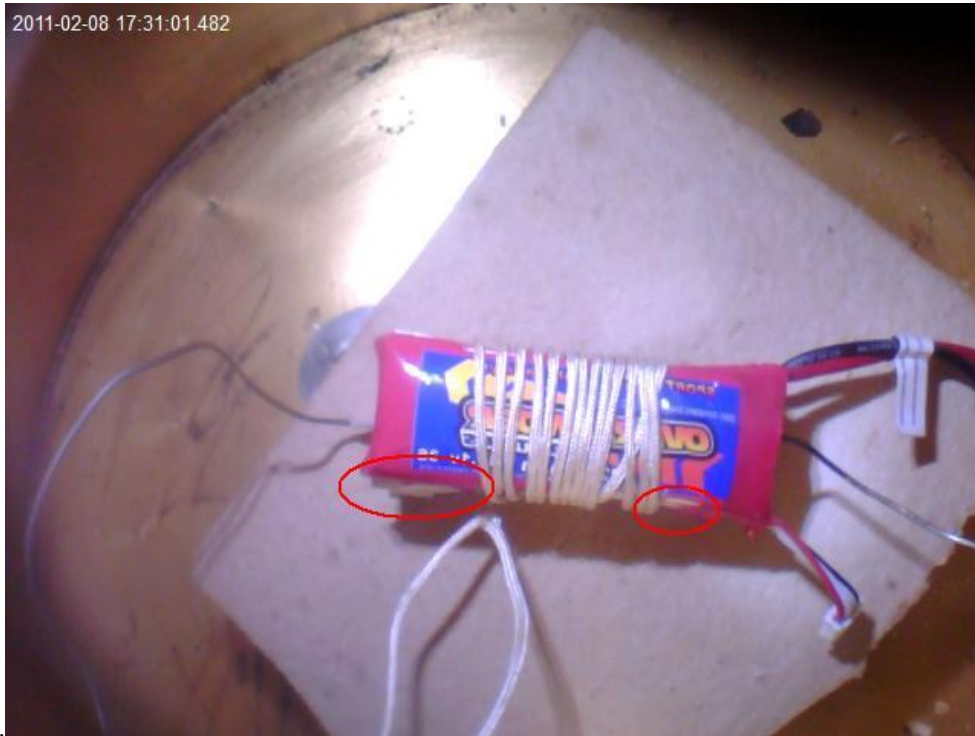
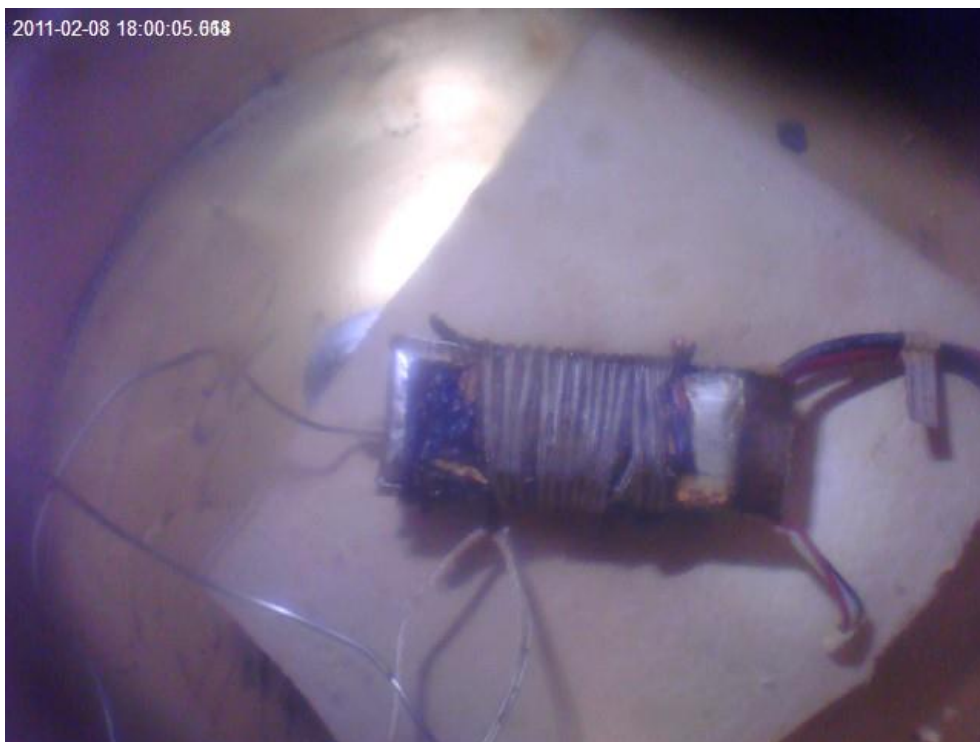
The gradual destruction of the battery due to the runaway was recorded with a camera looking into the calorimeter in real time and linked to the computer controlling the experiment. A couple of representative photos are shown below.
